INTERIM MEASURES – FINAL REPORT

Kanawha River Bank Stabilization and Residue Cleanup Flexsys Nitro Plant Facility, MP 42.1 Nitro, West Virginia

Project No. 01-0081-140

February 2004

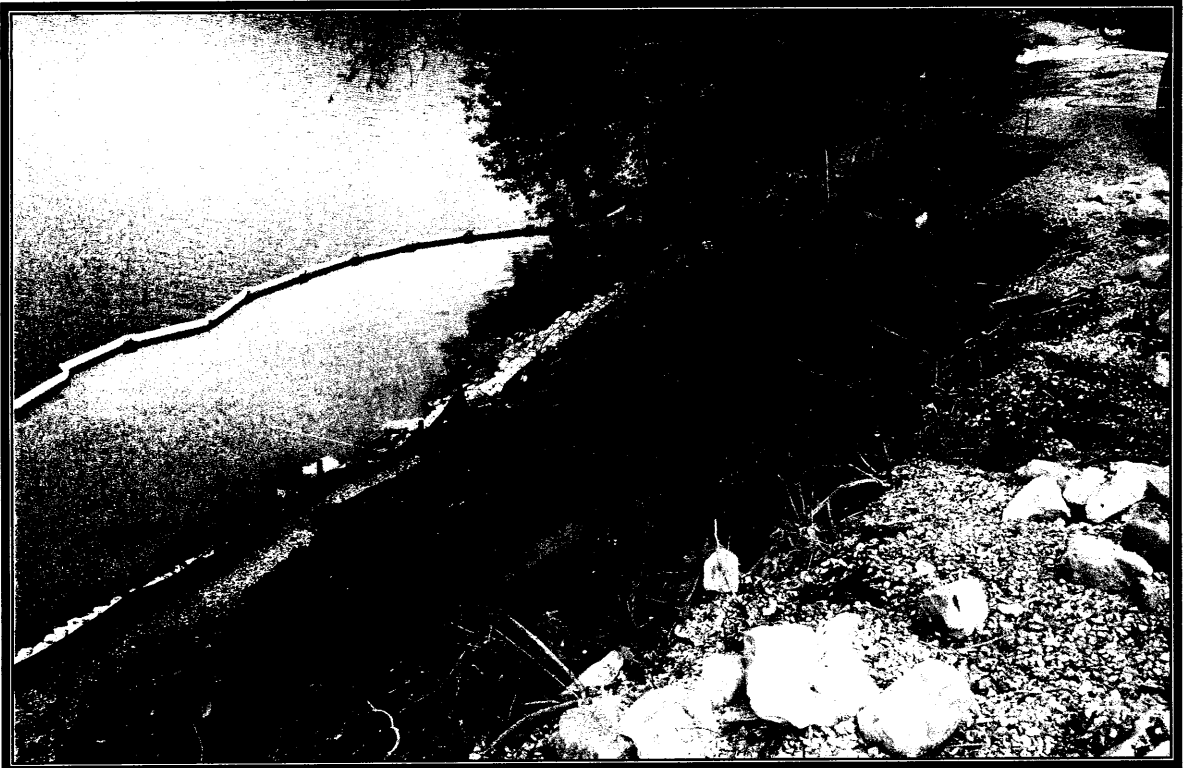
Photo 13: Embankment Area After Removal of Topsoil and Construction Debris

The excavation procedures began with careful removal of the construction/demolition materials existing on the surface of the slope. The excavated materials, which were not stained by the residue material, were placed in the appropriate labeled roll-off container. Those construction/demolition materials, which had been in contact with or had been impacted by the tar residue material, were separated and placed in the appropriately designated roll-off containers.

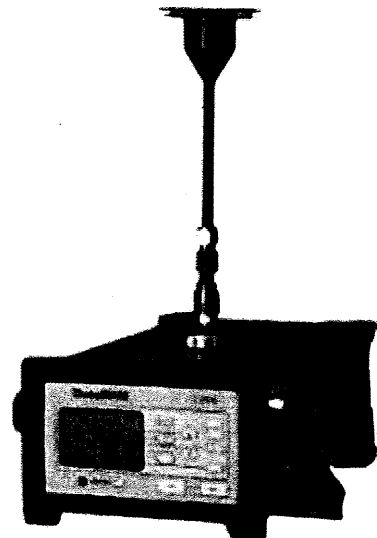
DataRAM with Omnidirectional Sampling Inlet for ambient monitoring

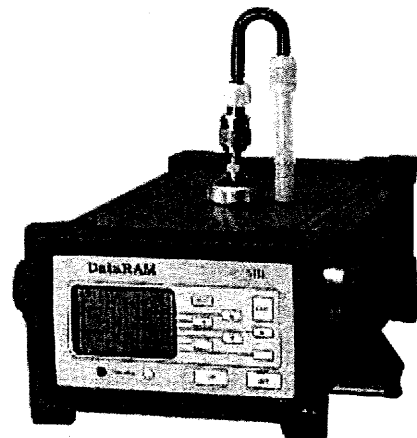
*DataRAM with Cyclone
Precollector for respirable
particle measurements*

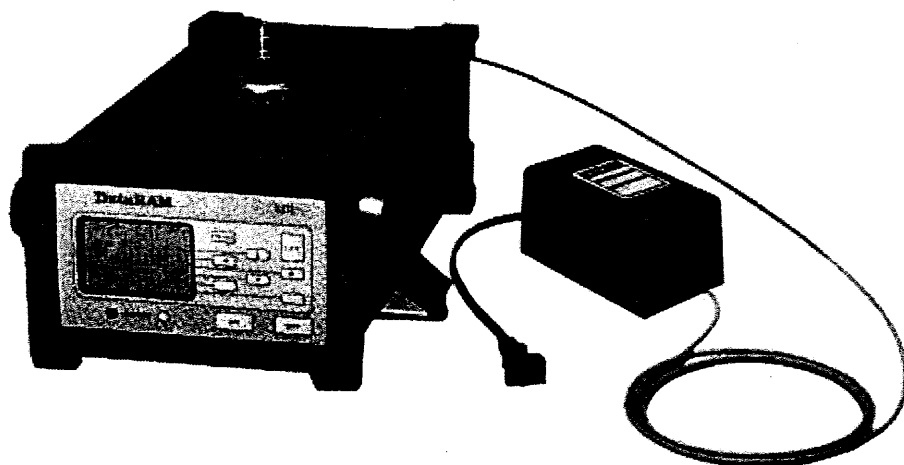
DataRAM can be powered by a rechargeable internal battery or an external power source
